5 inch Dredge Model 5109H

Product Report

By CAESAR J. MILCH

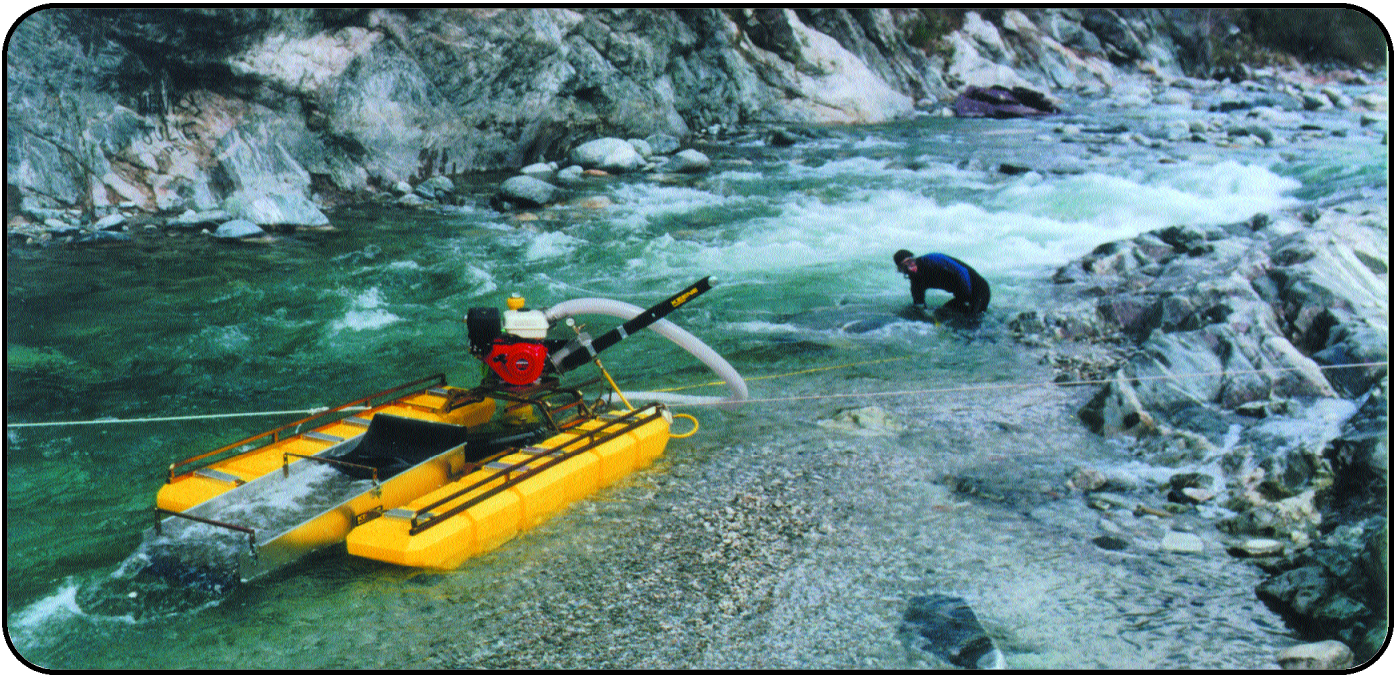
KEENE ENGINEERING'S 5" EDUCATION DREDGE EQUIPPED WITH NEW OVER/UNDER DOUBLE SLUICE BOX.. MODEL 5109H.
